An Open Letter to Metro-North Railroad Customers

*A Review of the Actions Taken by Metro-North
Railroad in Response to
Multiple Heat-Related Incidents on the
New Haven Line
July 22, 2011*

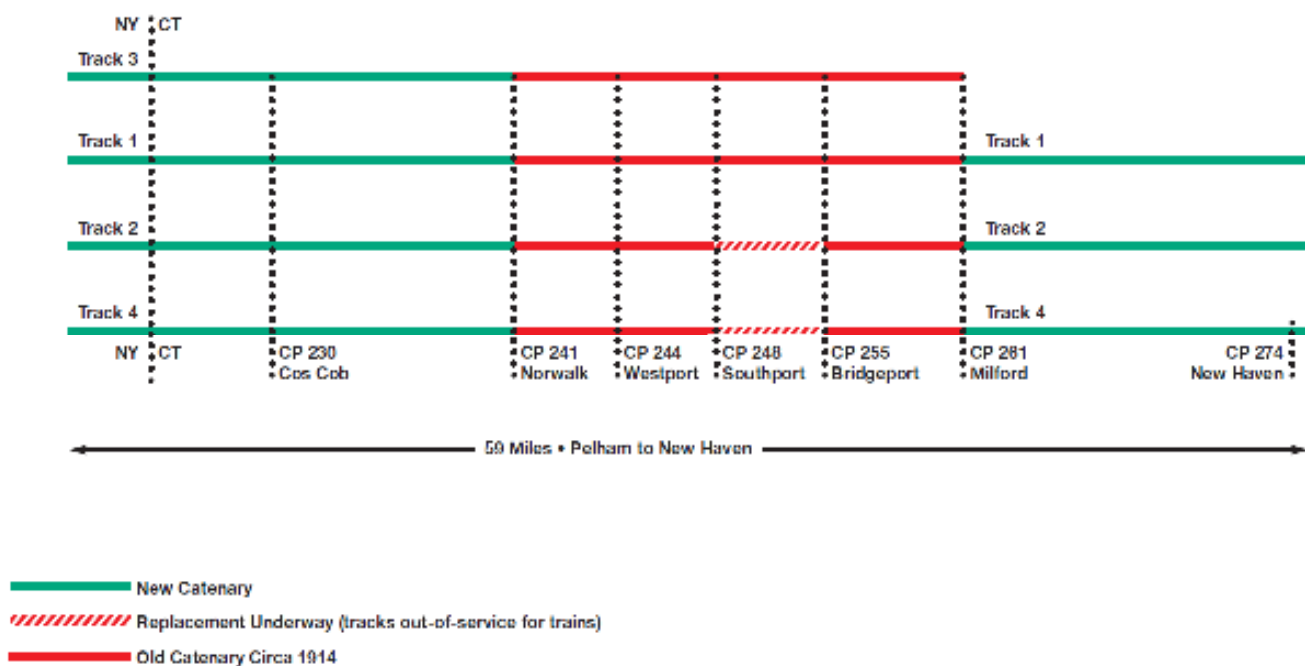
Current Status of New Haven Line Catenary System

CDOT commenced its catenary replacement in 1996. Completion is planned for 2015. Today, of the 172 miles of catenary on the New Haven Line in the State of Connecticut, 60% is the new constant tension system and 40% is either the original antiquated system or out of service for repair. MNR's operation is particularly vulnerable in the 7-mile stretch between Southport and Bridgeport. Of the four tracks in that area, 2 tracks are out of service for catenary replacement and bridge work; all trains, therefore, must operate on the other two tracks under old catenary. This system is decades past its useful life and the fragile condition of the system leads to regular failures, significantly impacting service reliability.

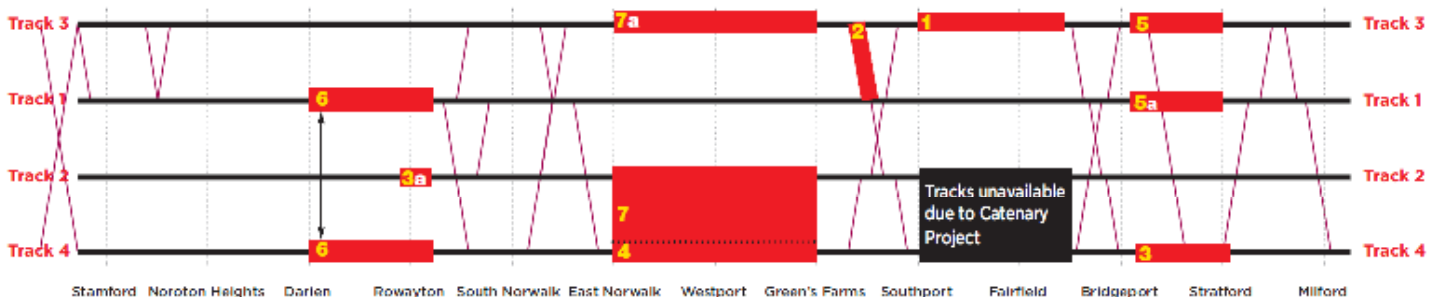
New Haven Line East of Stamford July 22, 2011 After 1:30 PM

1	CMV Inspection/Sagging Wire	12:59 PM - 2:45 PM
2	13 at CP 24B Switch Failure	1:34 PM - 11:00 PM
3	Train 1526 Pantograph Damage	1:34 PM - 3:14 PM
3a	10 mph Track Kink	1:42 PM - 11:59 PM
4	Train 1532 Sagging Wire	2:51 PM - 9:15 PM
5	Train 1573 Pantograph Damage	4:24 PM - 8:04 PM
5a	Train 1169 Rescue of Train 1573	4:25 PM - 5:37 PM
6	Transformer Fault at South Norwalk	4:32 PM - 6:25 PM
7	Train 1536 Disabled at CP 241	4:31 PM - 6:25 PM
7a	Train 1538 Rescue of Train 1536	4:40 PM - 4:59 PM
